**RE: Northern Pulp Nova Scotia - Environmental Assessment Focus Report - Replacement Effluent Treatment Facility**

**RE: Northern Pulp Nova Scotia Focus Report**

## **RE: Previous Submission Environmental Assessment**

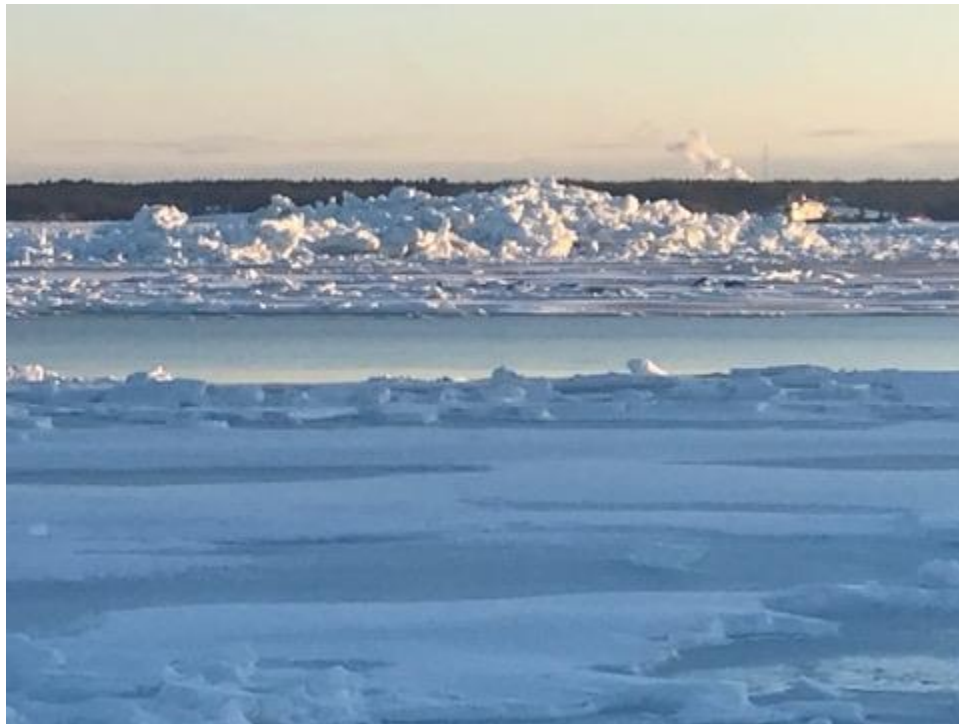
**Figure 1: Ice southeast of Caribou lighthouse along proposed pipe route (March 4<sup>th</sup>, 2019)**

The new data obtained as part of Northern Pulp's Focus report has verified the soft sandy soil conditions and found extremely alarming rates of ice scouring directly along the proposed route. The report has also confirmed extensive ice grounding located along the shallow area in Figure 1 (Figure 2 of previous submission). Due to the predominately sandy soil along the proposed route, all of the depths of scouring obtained are subject to some degree of error, as the soil quickly infills the scouring. CSR states that all scouring was from the 2018-2019 winter, as can be expected due to quickly changing sandy bottom continuously subject to tidal and wave action. The question is how much infill had taken place from the time the ice left until the survey was completed?

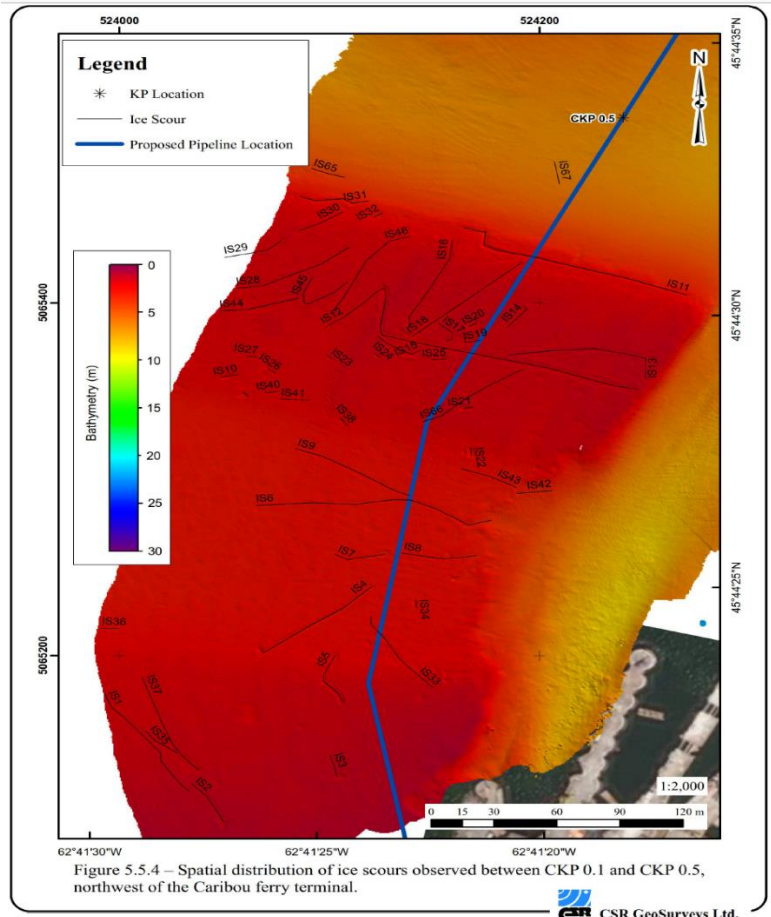
Figure 2 is one of many figures in CSR's report depicting the ice gouge locations along the proposed route. The blue line shows the proposed pipeline route while the several black lines show ice gouges found by CSR's survey. The figure illustrates a portion of the pipe route where depths are as shallow as 1 meter. This figure along with many others are severally alarming when looking at the possibility of ice impact on the pipe. Considering that founded gouges have measured lengths of up to 260 meters and widths of up to 6 meters, this data is not something to take lightly. If there is any amount of error in forecasting the maximum depth of ice gauging there is a large possibility of ductile pipe failure due to direct impact with catastrophic repercussion to the surrounding marine environment.

**Figure 2: Ice Gouging along a small section of the Proposed Route (P.104, Appendix 2.2)**

There is too much at stake to fast track the design process of the pipe. A full ice report including historical data and multiple surveys and site visits in winter months must be conducted to ensure the ice effects are modelled properly. Before the Minister can approve the proposed project, clear engineered documents including a leak detection plan for the marine portion of the pipe must be submitted for public review, plans should include a monitoring system with real time data. Failure to do so could lead to the catastrophic structural failure of the pipe due to direct ice impact or cyclic fatigue loadings exceeding allowable limits. Effluent prematurely released in shallow waters due to a pipe break and gone undetected would have irreversible effects on the surrounding marine ecosystems.

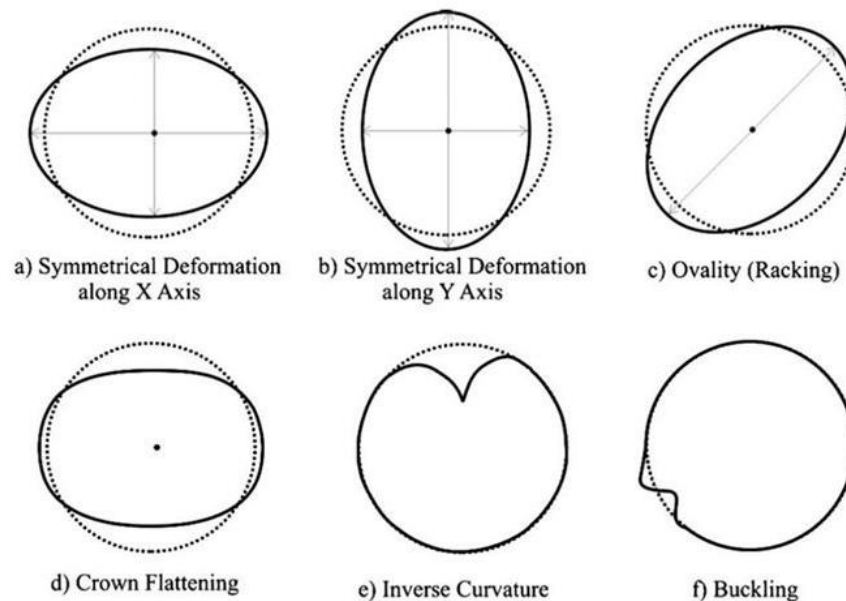
geometric stability is eventually lost and the crown of the pipe will begin to flatten and eventually reverse leading to reverse curvature collapse of the pipe Figure 1 shows observed pipe deformation patterns that lead to failure due to increased pipe deflections (Plastic Pipe Institute, 2014).

**Figure 1: Observed deformations of installed HDPE pipelines (Motahari & Abolmaali, 2010)**

Figure 1 is from a study published in the Journal of Transportation Engineers of the American Society of Civil Engineers (ASCE). The study included structural monitoring with video and laser surveillance of over 15,000ft (96 pipelines) of buried HDPE pipe across the USA. It was concluded that the majority of pipelines had actual deformations in excess of design code limits (Motahari & Abolmaali, 2010). This study gives great insight into the possible repercussions of not accurately modeling induced strains in buried HDPE pipes.

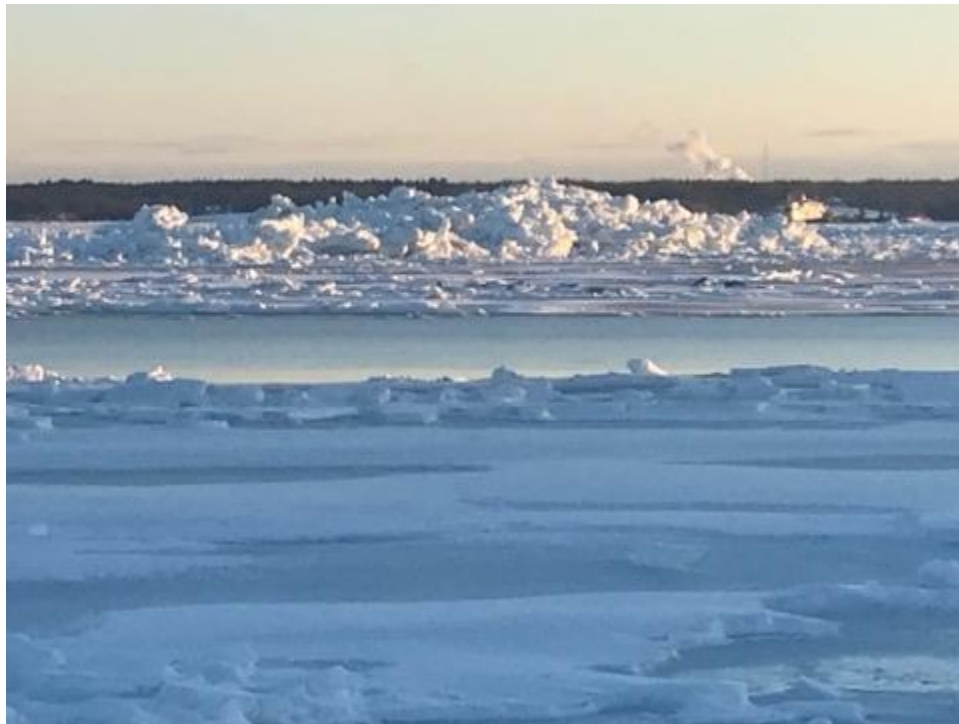
**Figure 2: Ice southeast of Caribou lighthouse along proposed pipe route (March 4<sup>th</sup>, 2019)**

This photo shows extensive ice directly over the proposed pipe route. Locations where water depths are as shallow as 1 meter have ice piles of 3-4-meter heights above sea level. It is not unlikely to conclude from these photos alone that potential for ice impact at a depth of 2m below seafloor bottom in a soft bottom is a very real possibility that could lead to a ductile failure resulting

in the catastrophic event of premature released effluent into the Caribou harbour. Figure 3 shows more ice further north along proposed pipe route.

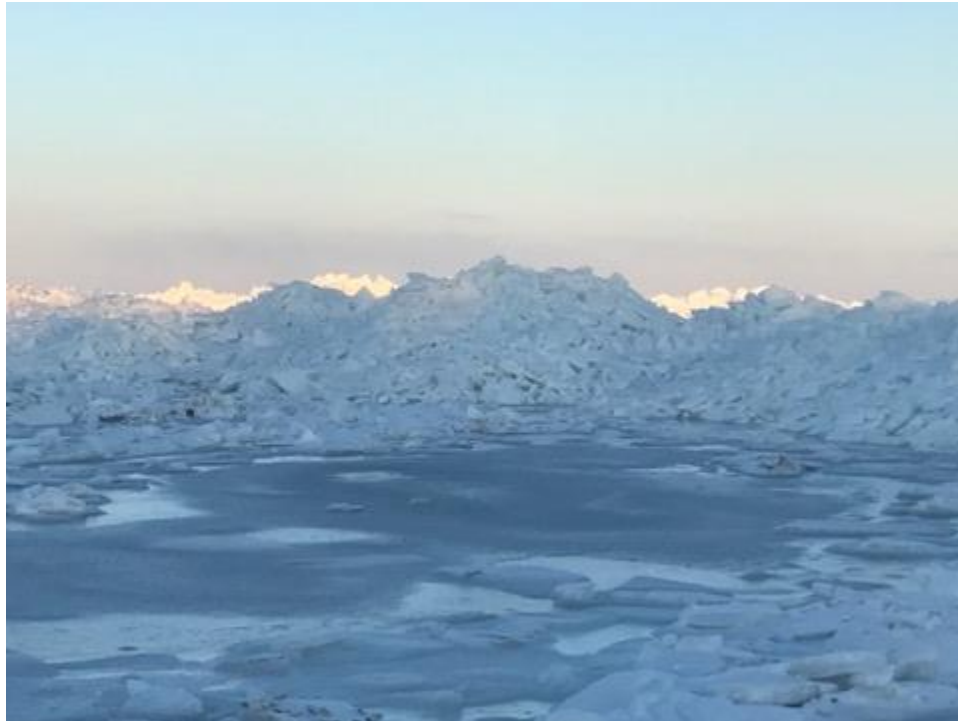
**Figure 3: Ice east of Caribou lighthouse along proposed pipe route (March 4<sup>th</sup>, 2019)**
