**RE: Northern Pulp Nova Scotia - Environmental Assessment Registration Document-
Replacement Effluent Treatment Facility**

1.0 SEAFLOOR CHARACTERISTICS OF PROPOSED ROUTE

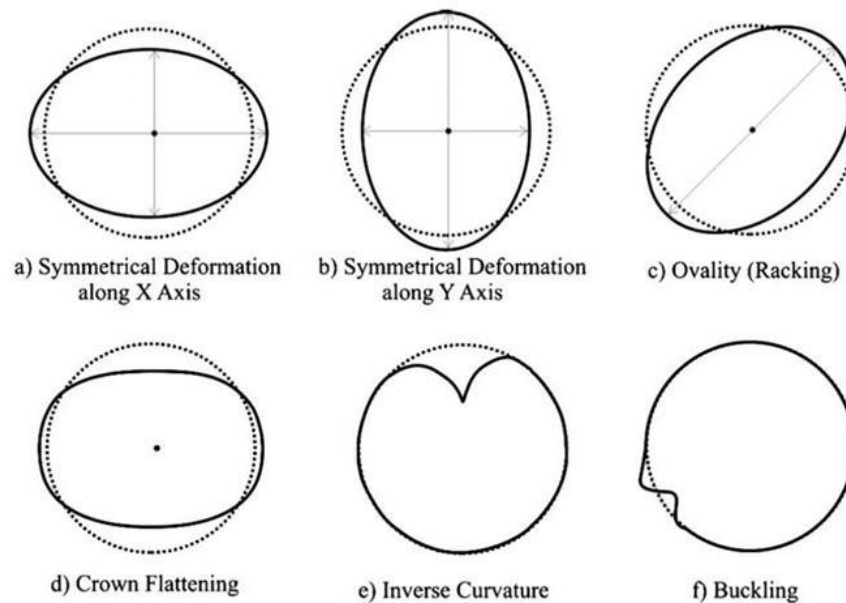
Figure 1: Observed deformations of installed HDPE pipelines (Motahari & Abolmaali, 2010)

Figure 1 is from a study published in the Journal of Transportation Engineers of the American Society of Civil Engineers (ASCE). The study included structural monitoring with video and laser surveillance of over 15,000ft (96 pipelines) of buried HDPE pipe across the USA. It was concluded that the majority of pipelines had actual deformations in excess of design code limits (Motahari & Abolmaali, 2010). This study gives great insight into the possible repercussions of not accurately modeling induced strains in buried HDPE pipes.

reverse leading to reverse curvature collapse of the pipe Figure 1 shows observed pipe deformation patterns that lead to failure due to increased pipe deflections (Plastic Pipe Institute, 2014).

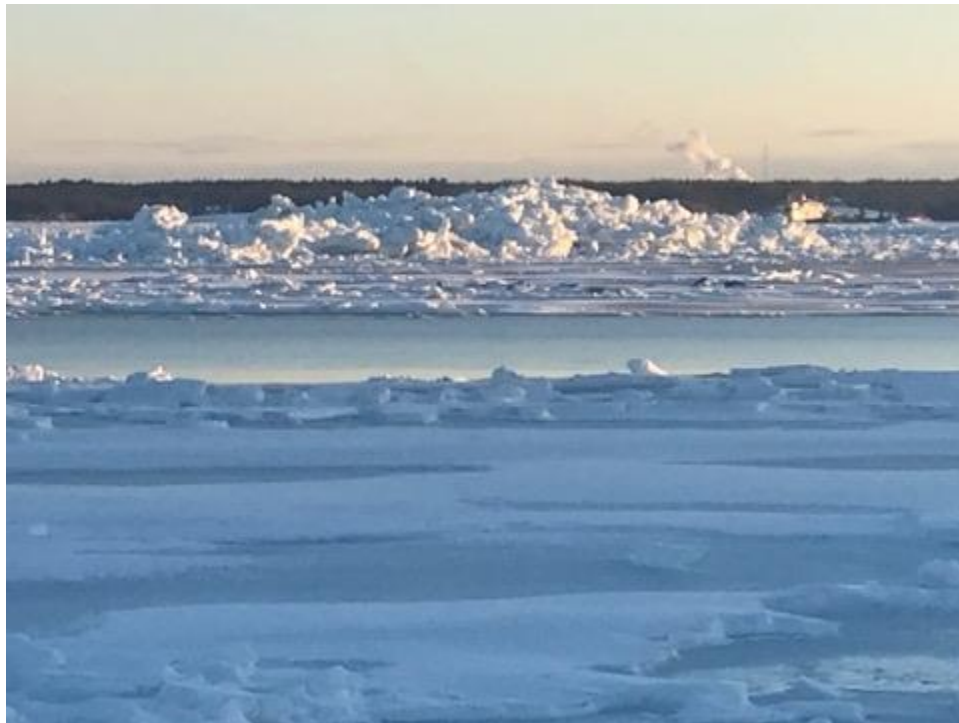
Figure 2: Ice southeast of Caribou lighthouse along proposed pipe route (March 4th, 2019)

This photo shows extensive ice directly over the proposed pipe route. Locations where water depths are as shallow as 1 meter have ice piles of 3-4-meter heights above sea level. It is not unlikely to conclude from these photos alone that potential for ice impact at a depth of 2m below seafloor bottom in a soft bottom is a very real possibility that could lead to a ductile failure resulting in the catastrophic event of premature released effluent into the Caribou harbour. Figure 3 shows more ice further north along proposed pipe route.

material induced repeatedly over a relatively long time) (Zhang, 2005). Brittle failure due to ice impact could occur if any of the following project tasks are neglected: complete a site survey of ice conditions, complete a hydrographic survey depicting any potential ice scours, bury pipe at an adequate distance to account for extreme ice event. Although Northern Pulp shows a pipe buried with cover of approximately 2 meters, they have not completed any of the pre-design field work required to ensure that the pipe is not at risk of failure. When determining extreme ice scouring events, it is also recommended that ice scour surveys be carried out more than once, spaced out over time to gain an accurate depiction of the ice and seafloor interaction (C-Core, 2004). Grounding models such as the one created for a tunnel project crossing the Strait of Belle Isle, Newfoundland can also be carried out to gain insight into ice activity in a given region (C-Core, 2004). The soft soil and shallow design depth of the pipe (approximately 2 meters) also poses concerns for ice and seafloor interaction. If large ice accumulation was present and gouged the seafloor to the unknown depths of the soft bottom there would be no evidence of such gouges once the ice had melted as the sand would infill the gouges within a couple tide cycles. Figure 2 and Figure 3 are a photo's taken March 4th, 2019 from the Caribou light house, the PEI ferry can be seen docked in the background.

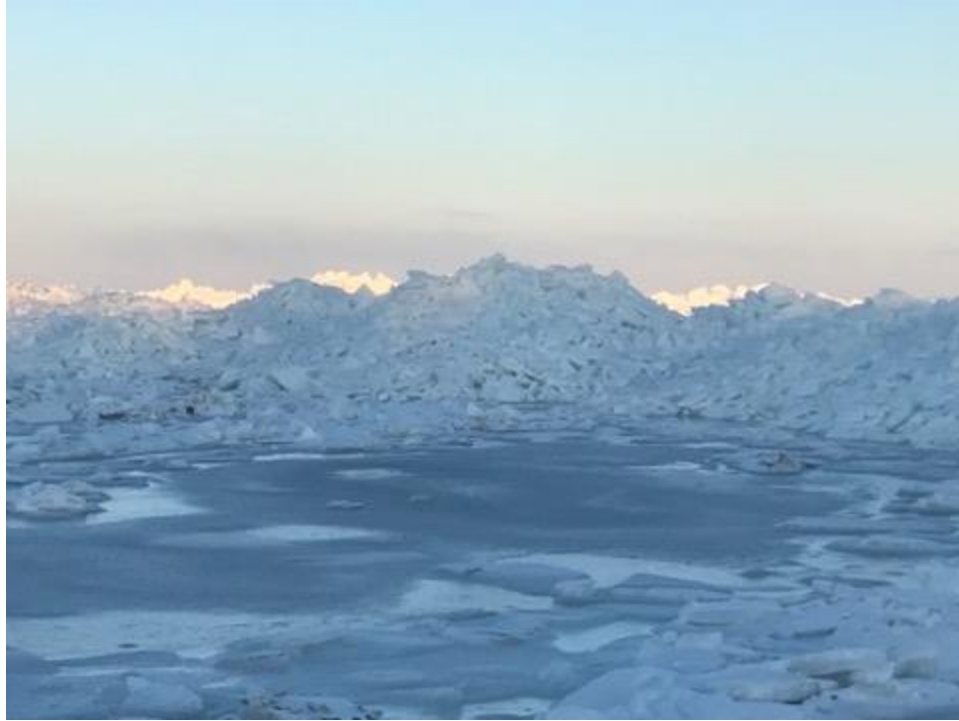
Figure 3: Ice east of Caribou lighthouse along proposed pipe route (March 4th, 2019)
